Illicit Discharge Detection & Elimination Program

2016 Outfall Field Screening Program

CITY OF APPLETON DEPARTMENT OF PUBLIC WORKS CALUMET, OUTAGAMIE & WINNEBAGO COUNTIES, WISCONSIN

DECEMBER 8, 2016 McM. No. A0003-9-16-00378.02

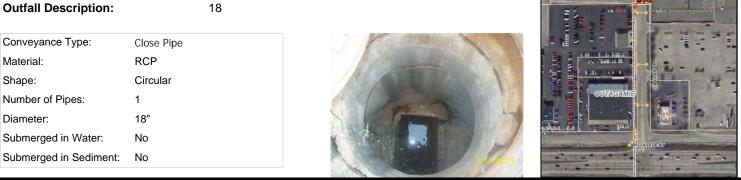
Southwest corner of Lilas Dr/Franklin St intersection

Date of Inspection: 7/21/2016	Inspector: Nolan Knapp	Previous Rain Fall (Hours): > 72
Flow:	None	
Physical Indirectors:	None	
Overall Outfall Characterization:	Unlikely	
Non-Illicit Discharge Concerns:	No	
Comments:	Standing water in the bottom of get a sample. No evidence of p	manhole. Water depth too shallow to rior illicit discharge.

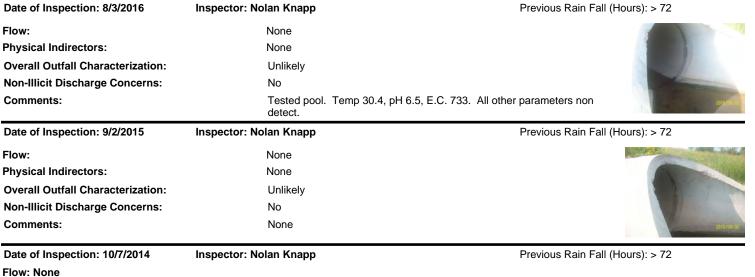
Indicator	Description		Comments
Outfall Damage:			
Deposits / Stains:			
Abnormal Vegetation:			
Poor Pool Quality:	Colors		Cloudy water observed at time of inspection.
Pipe Benthic Growth:			
Overall Outfall Characteriz	zation:	Unlikely	
Non-Illicit Discharge Co	oncerns:	No
